**Flood Control Project Maintenance
Levee Inspections**

Maintenance Issue Types Only, Levee Inspection Report By Mile - Spring 2016

Reclamation District No. 2058 Pescadero

Waterway	Bank	Unit Miles	Inspection Start/End	Inspector
Unit No. 01 Paradise Cut	Left	6.58	03/22/2016 03/22/2016	Maksim Khashchuk

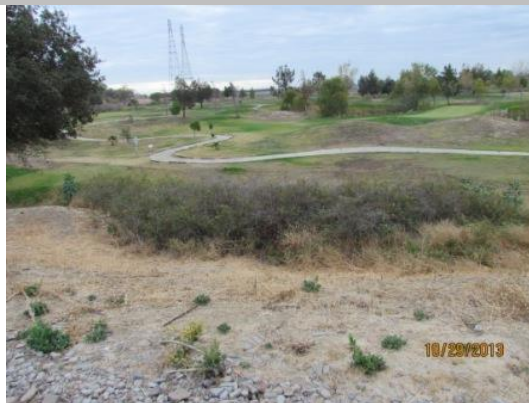
Photo 1 of 1 : SP_2016_RD2058_111_4_20160229_00004.jpg

LM Start	0.23	Rating **	M	Issue No.	4
LM End	0.23	Issue Type +	Ma	Location *	LS
Category	Earthen Levee			GPS Latitude/Longitude	
				Start	End
Item	Vegetation			37.804351 °	37.804351 °
				-121.418433 °	-121.418433 °
DWR ID	DWR_RD2058_01_f_2013_4				
Comment Code					
V2 : Remove the wild growth other than native grasses from the levee slopes.					
Inspector Comment					
Wild rose on the levee. This area is riparian rabbit habitat.

View of the wild rose habitat for the brush rabbit.

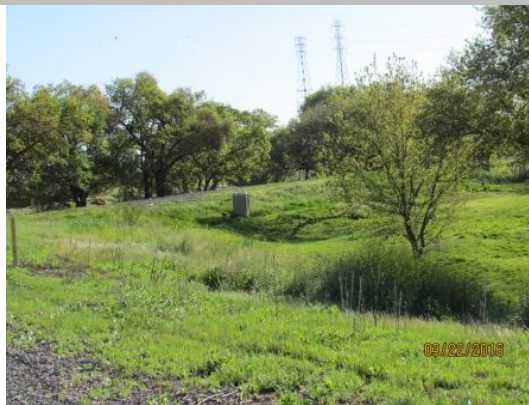
Photo 1 of 1 : SP_2016_RD2058_111_19_20160324_00038.jpg

LM Start	0.25	Rating **	M	Issue No.	19
LM End	0.30	Issue Type +	Ma	Location *	LS
Category	Earthen Levee			GPS Latitude/Longitude	
				Start	End
Item	Vegetation			37.804461 °	37.804756 °
				-121.418241 °	-121.417384 °
DWR ID	DWR_RD2058_01_s_2016_19				
Comment Code					
V1 : Control annual grass and weeds on the levee slopes and easements.					
Inspector Comment

View of the vegetation on the landside levee slope.

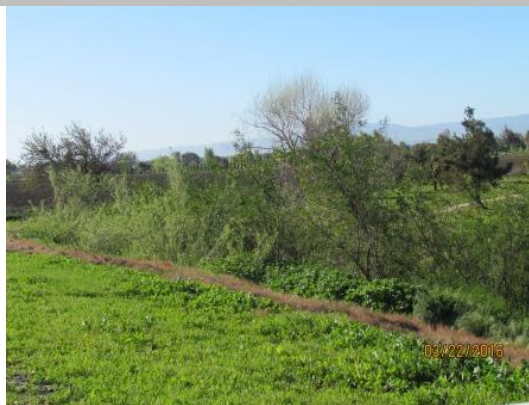
Photo 1 of 1 : SP_2016_RD2058_111_21_20160324_00039.jpg

LM Start	0.41	Rating **	M	Issue No.	21
LM End	0.45	Issue Type +	Ma	Location *	LS
Category	Earthen Levee			GPS Latitude/Longitude	
				Start	End
Item	Vegetation			37.803799 °	37.803436 °
				-121.415675 °	-121.415283 °
DWR ID	DWR_RD2058_01_s_2016_21				
Comment Code					
V2 : Remove the wild growth other than native grasses from the levee slopes.					
Inspector Comment

View of the vegetation on the landside levee slope and toe.

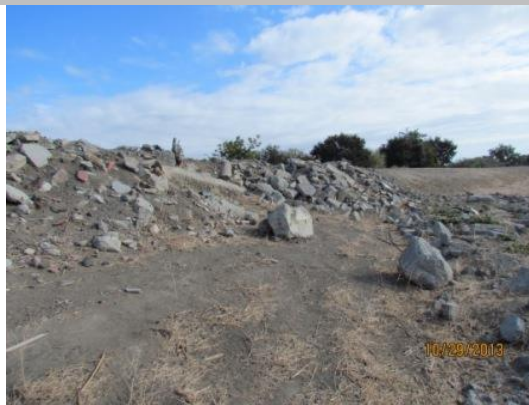
Photo 1 of 1 : SP_2016_RD2058_111_11_20160229_00005.jpg

LM Start	1.82	Rating **	U	Issue No.	11
LM End	1.82	Issue Type +	Ma	Location *	LS
Category	Earthen Levee			GPS Latitude/Longitude	
				Start	End
Item	Encroachments			37.804785 °	37.804785 °
				-121.391524 °	-121.391524 °
DWR ID	DWR_RD2058_01_f_2013_11				
Comment Code					
MA : Material					
Inspector Comment					
Pile of concrete contains rebar on landside slope obstructing visibility and access.

View of the concrete with rebar placed on the landside slope.

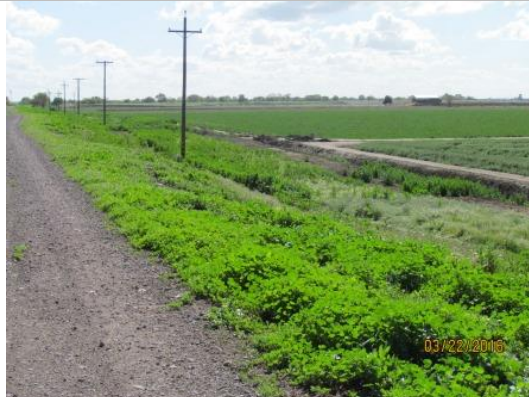
Photo 1 of 1 : SP_2016_RD2058_111_23_20160324_00040.jpg

LM Start	2.44	Rating **	M	Issue No.	23
LM End	2.71	Issue Type +	Ma	Location *	LS
Category	Earthen Levee			GPS Latitude/Longitude	
				Start	End
Item	Vegetation			37.802608 °	37.801509 °
				-121.380638 °	-121.375805 °
DWR ID	DWR_RD2058_01_s _ 2016_23				
Comment Code					
V1 : Control annual grass and weeds on the levee slopes and easements.					
Inspector Comment

View of the vegetation on the landside levee slope.

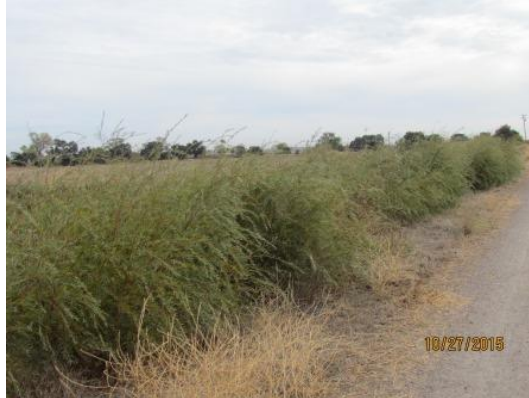
Photo 1 of 1 : SP_2016_RD2058_111_17_20160229_00008.jpg

LM Start	2.75	Rating **	A/W	Issue No.	17
LM End	2.75	Issue Type +	Ma	Location *	WS
Category	Earthen Levee			GPS Latitude/Longitude	
				Start	End
Item	Vegetation			37.801367 °	37.801367 °
				-121.375094 °	-121.375094 °
DWR ID	DWR_RD2058_01_f_2015_17				
Comment Code					
V2 : Remove the wild growth other than native grasses from the levee slopes.					
Inspector Comment					
LMA removed vegetation fall 2015.

View of the willows on the waterside levee slope.

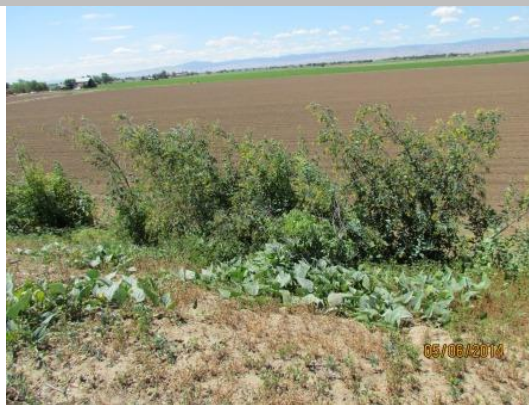
Photo 1 of 1 : SP_2016_RD2058_111_22_20160229_00011.jpg

LM Start	3.91	Rating **	A/W	Issue No.	22
LM End	3.91	Issue Type +	Ma	Location *	LS
Category	Earthen Levee			GPS Latitude/Longitude	
				Start	End
Item	Vegetation			37.789434 °	37.789434 °
				-121.361721 °	-121.361721 °
DWR ID	DWR_RD2058_01_s_2014_22				
Comment Code					
V2 : Remove the wild growth other than native grasses from the levee slopes.					
Inspector Comment					
LMA removed vegetation in Fall 2015.

View of the tall vegetation on the landside levee slope and toe.

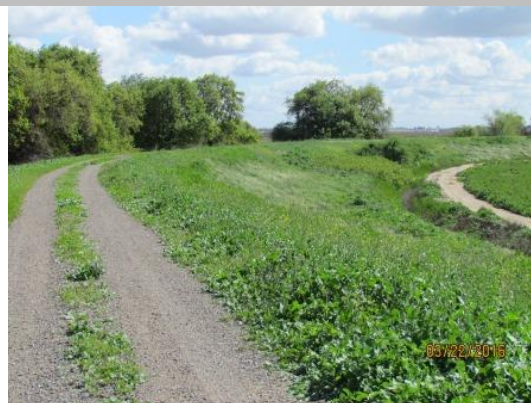
Photo 1 of 1 : SP_2016_RD2058_111_24_20160324_00041.jpg

LM Start	4.31	Rating **	M	Issue No.	24
LM End	5.58	Issue Type +	Ma	Location *	LS
Category	Earthen Levee			GPS Latitude/Longitude	
				Start	End
Item	Vegetation			37.789768 °	37.779132 °
				-121.354919 °	-121.339619 °
DWR ID	DWR_RD2058_01_s _ 2016_24				
Comment Code					
V1 : Control annual grass and weeds on the levee slopes and easements.					
Inspector Comment

View of the vegetation on the landside levee slope.

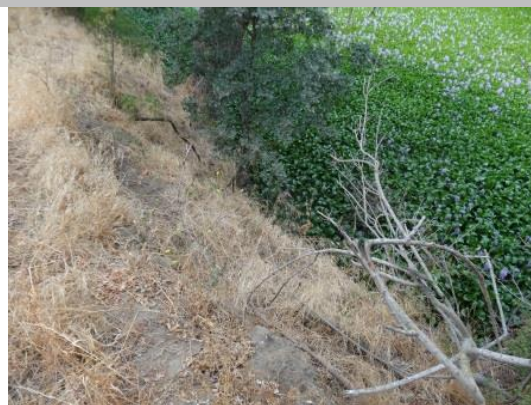
Photo 1 of 3 : SP_2016_RD2058_111_1_20160229_00001.jpg

LM Start	4.43	Rating **	M	Issue No.	1
LM End	4.47	Issue Type +	Ma	Location *	WS
Category	Supplemental			GPS Latitude/Longitude	
				Start	End
Item	DWR Erosion Survey			37.789810 °	37.789810 °
				-121.352490 °	-121.352490 °
DWR ID	DWR_RD2058_01_s _ 2016_1

Comment Code					
Inspector Comment					
08/04/2015: No significant change observed.					
08/26/2014: No significant change observed.					
08/28/2013: No significant change observed.					
07/26/2012: The site has been visited, and no significant change has been observed.					
09/02/2011: This site was not visited due to the time limit.					
09/22/2010: No significant change observed. Minor pocket erosions are lined at the lower bank. Two large Oak and Willow trees are on mid-slope and bench. The remaining bench was re-measured and found to be approximately 10 feet. There was no indication of active erosion on site during the site visit.					
08/05/2010: Recommended for annual assessment and monitoring of the site during flood events, per CLRO.					
07/23/2009: No major change observed since last visit; site is a 200-ft. long near-vertical berm erosion; recommend annual assessment and monitoring of the erosion site, per CLRO CES Evaluation 2008 Report; Site # is the same site previously reported as RM4.0,LM4.51; previously rated "U".

09/10/2008: Two large trees (2-3' DBH) with partial roots exposed.					
2007: Visited site 03/13/2007. [2015 Site ID:RD2058U01RM3.97]

Direct view of the erosion near a tree.

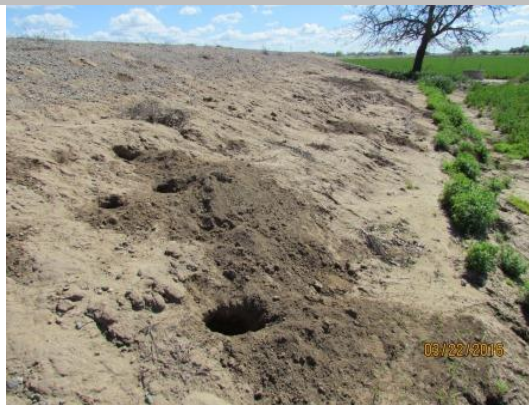
Photo 1 of 1 : SP_2016_RD2058_111_27_20160324_00042.jpg

LM Start	6.09	Rating **	U	Issue No.	27
LM End	6.10	Issue Type +	Ma	Location *	LS
Category	Earthen Levee			GPS Latitude/Longitude	
				Start	End
Item	Animal Control			37.773629 °	37.773503 °
				-121.333688 °	-121.333550 °
DWR ID	DWR_RD2058_01_s_2016_27				
Comment Code					
A3 : No rodents visible, but rodent burrows visible; need to backfill and compact or grout burrows.					
Inspector Comment

View of the rodent burrows on the landside levee slope.
